Inspection Report

Property Address:
1111 Wooded Rd
Louisville Ky 40205

HayStack Inspection Services

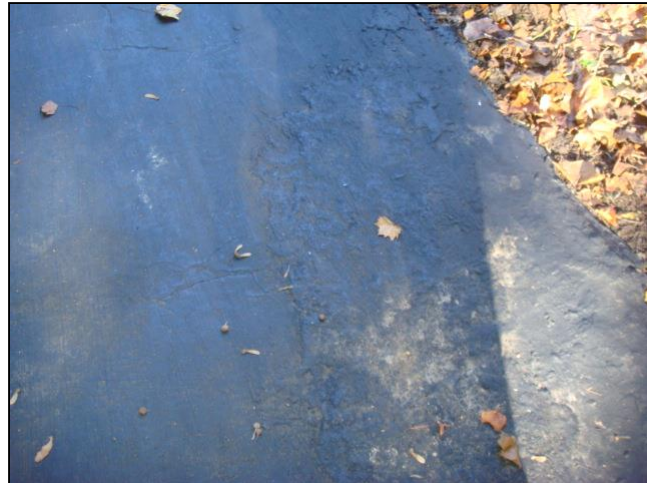
1.0 Item 1(Picture)

1.0 (1) The asphalt driveway has some deterioration visible. With the weather conditions in this region, surfaces will settle and crack even with the presence of expansion joints due to freezing and thawing. Suggest keep any gap between the driveway and foundation wall sealed with exterior sealant as regular maintenance.

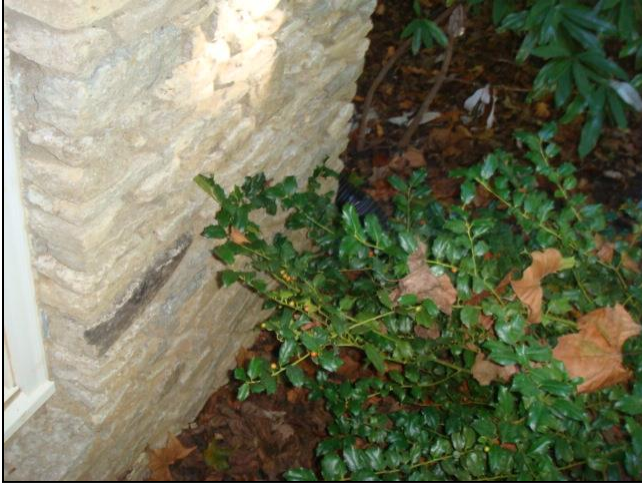
1.0 Item 2(Picture)

1.0 (2) There is landscape/vines/shrubs against the house in several areas. Shrubbery and vegetation should be kept cut back at least 9-12" to prevent wood boring insect infestation and possible moisture accumulation and damage. All wood trim and siding should be properly painted and caulked to prevent rot and possible interior moisture damage.

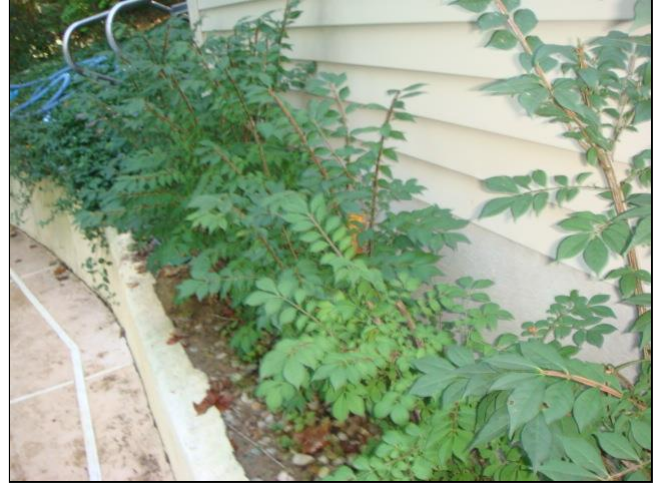
1.0 Item 3(Picture)

1.0 (3) The foundation grading slopes towards the foundation at the right, front of the structure. It is important to maintain a positive slope away from the foundation to prevent water penetration and/or moisture issues. Suggest check sellers disclosure as to prior water penetration-improve grading so that water sheds away from structure. As regular maintenance, keep grading built up, gutters clean and clear of debris that will cause drainage issues and add splashblocks or keep aligned under downspouts. For best results, add downspout extenders so water is carried as far as possible away from the house.

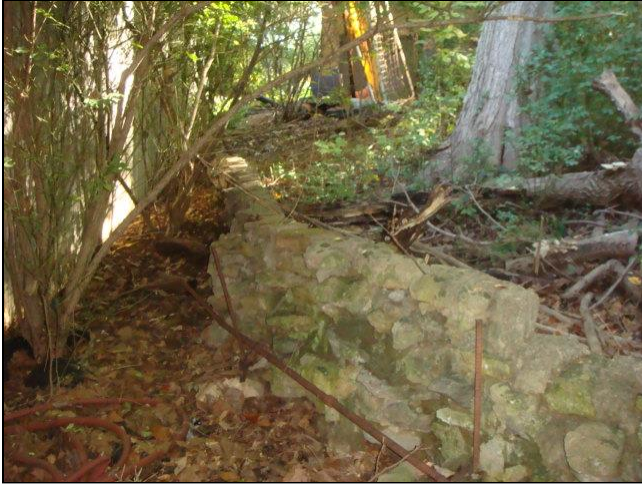
1.0 Item 4(Picture)

1.0 (4) There are retaining walls in place next to the house. The walls looked fine the day of the inspection. Be aware that these walls can move over time and that movement can have a structural effect on the house. Suggest you monitor retaining walls and call a qualified contractor if you see movement.

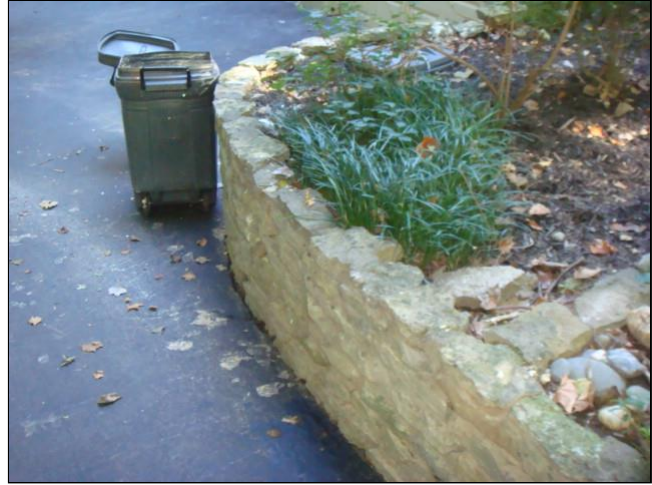
1.0 Item 5(Picture)

Also, one of the walls has spray foam added. It is suggested that if you want to make maintenance type upkeep to these walls you do so with cement grout "tuck pointing" in the future.

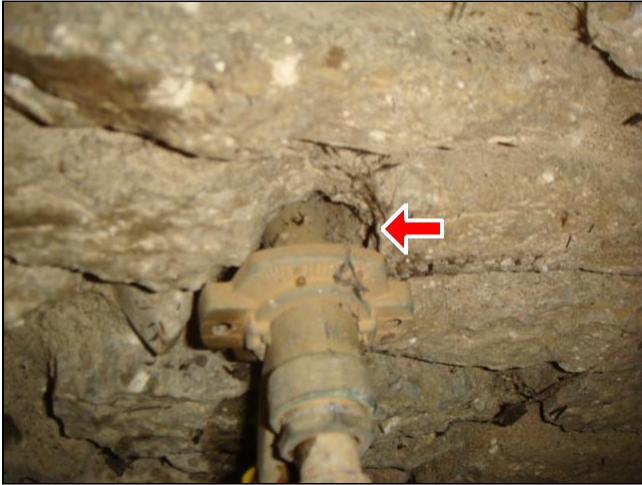
1.3 Item 1(Picture)

1.3 (1) Suggest keep all exterior wall penetrations (ex: electrical penetrations, a/c refrigeration lines, gas lines, hose spigots and dryer vents) sealed as regular maintenance. Sealing around penetration keeps moisture and pests from entering the finished spaces.

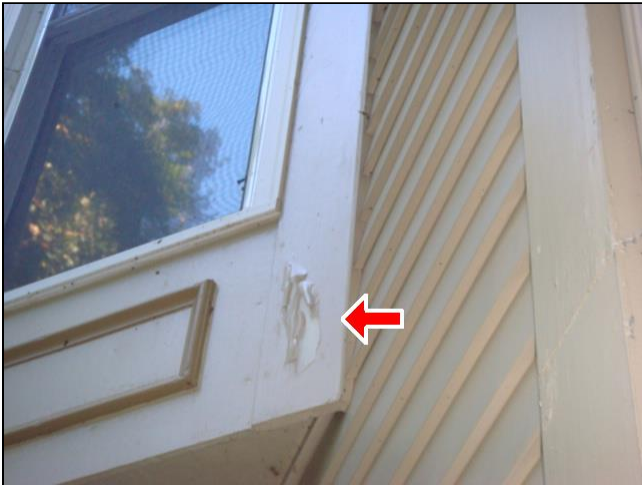
1.3 Item 3(Picture)

1.3 (2) There are spots on the wood trim that have lost paint and there is exposed wood. The loss of paint can cause deterioration of the wood and attract wood destroying insects. Painting and sealing of wood areas are necessary as regular home maintenance. Suggest closely monitor the condition of paint and sealing and keep the wood exterior areas of your home in good condition.

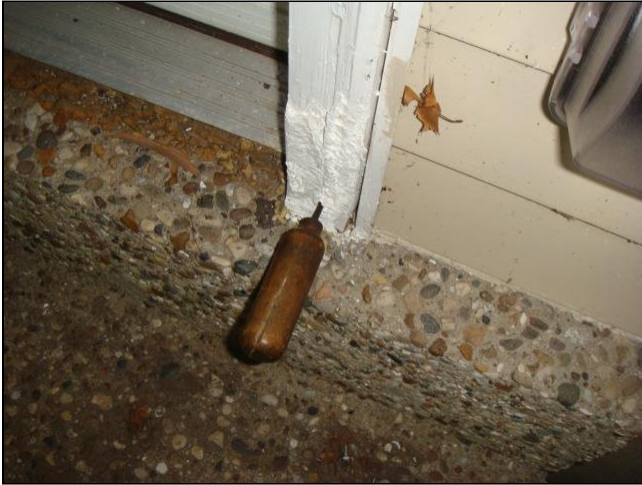
1.3 Item 5(Picture)

1.3 (3) There is rot/deterioration noted in some wood trim around the structure. These areas include, but are not limited to back basement door and fascia board on the roof. Suggest qualified contractor evaluate all wood trim and repair as necessary.

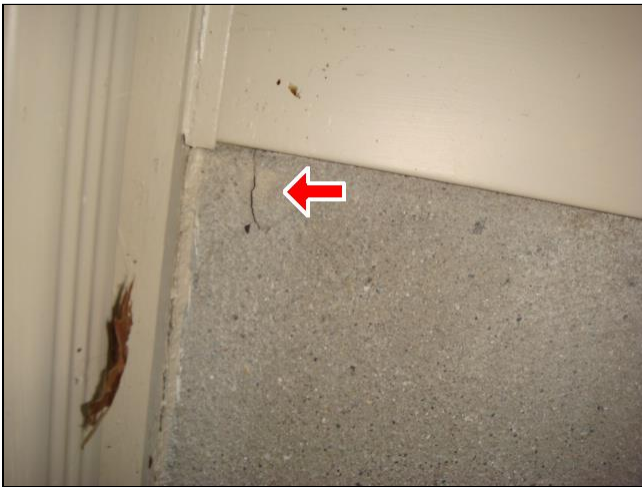
1.4 Item 1(Picture)

1.4 The stucco around the perimeter of the foundation has cracks and areas where it is chipped and loose. Stucco is a cosmetic covering over the foundation material, it is not unusual that imperfections and chipping/cracking occur. Suggest monitor and consult qualified contractor if cosmetic upgrades are desired in future.

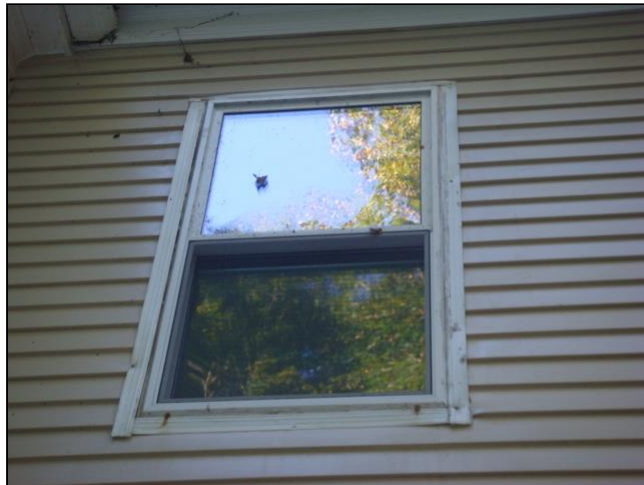
1.5 Item 1(Picture)

1.5 (2) One of the rear windows has a trim job that appears to be unprofessional. No issues were seen today. Suggest you monitor this and contact a qualified contractor if you see changes and need repairs in the future.

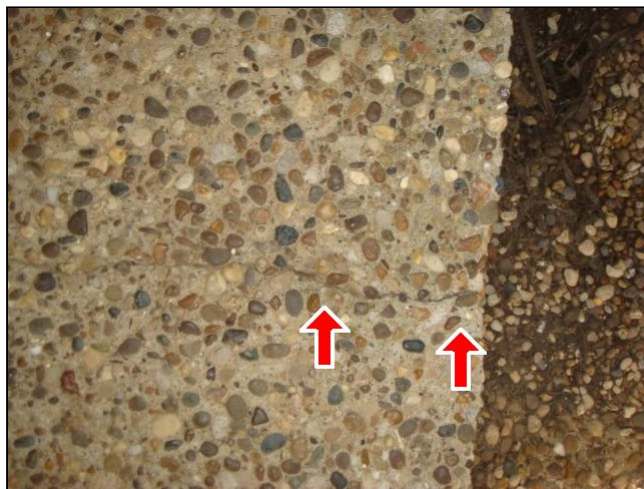
1.6 Item 1(Picture)

1.6 (1) The front concrete porch has typical cracks and settlement visible. With the weather conditions in this region, surfaces will settle and crack even with the presence of expansion joints due to freezing and thawing.

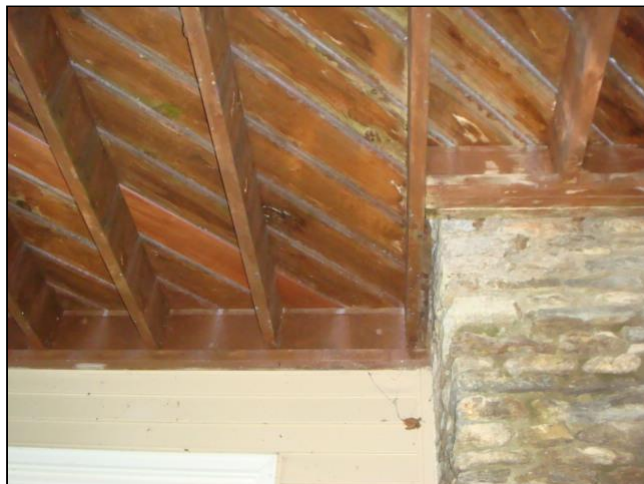
1.6 Item 2(Picture)

1.6 (2) The deck is +30 inches constructed with treated lumber. The ledger board is anchored to the wall with bolts and there are joist supports visible. The ledger board flashing is visible. Suggest keep the deck surface cleaned and sealed as regular maintenance-decking, railing and balusters should be kept secured.

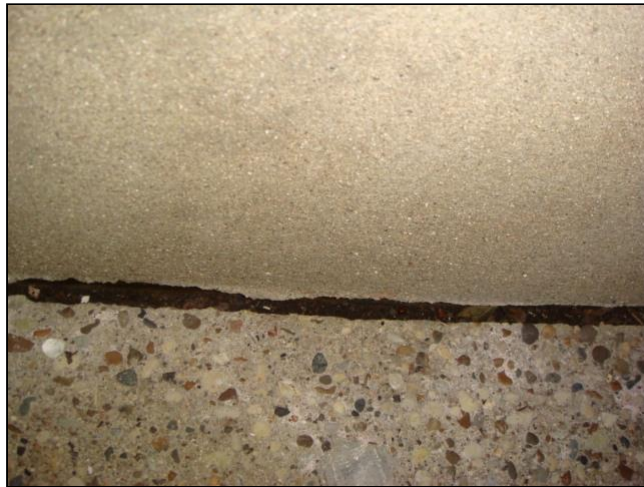
1.6 Item 3(Picture)

1.6 (3) There are cracks visible where the house foundation meets the porch foundation wall. This is a normal spot to see cracking, and it does not effect the inner foundation walls. Keep this gap sealed as regular maintenance to limit moisture intrusion here.

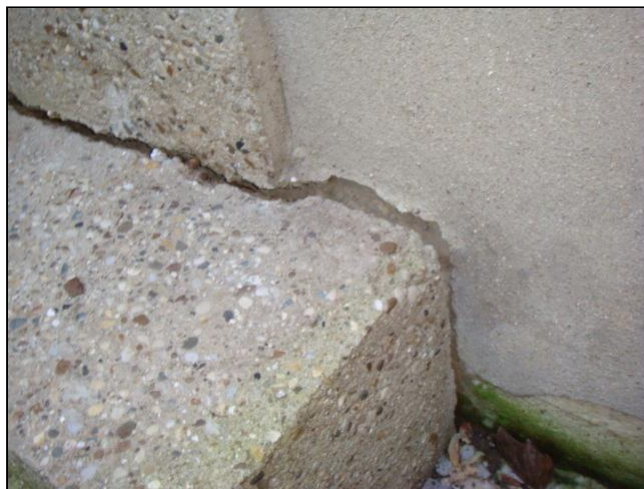
1.6 Item 4(Picture)

1.6 (4) The rear concrete stair(s) have cracks visible where the step meets the stoop/landing. This is a normal spot to see cracking and does not effect the functionality of the structure.

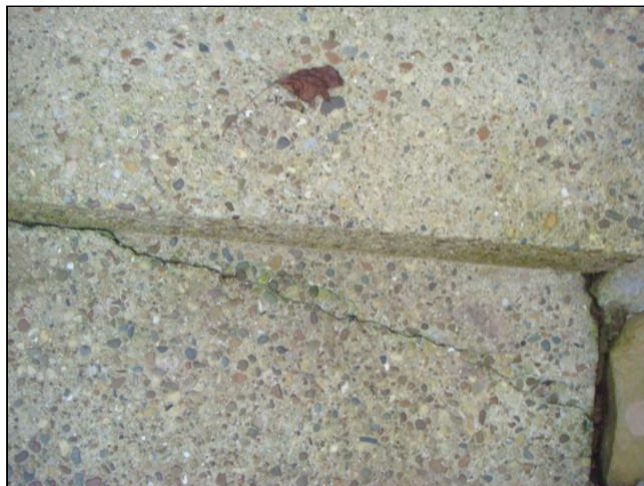
1.6 Item 5(Picture)

1.6 (5) The concrete patio has typical cracks and settlement visible. With the weather conditions in this region, surfaces will settle and crack even with the presence of expansion joints due to freezing and thawing.

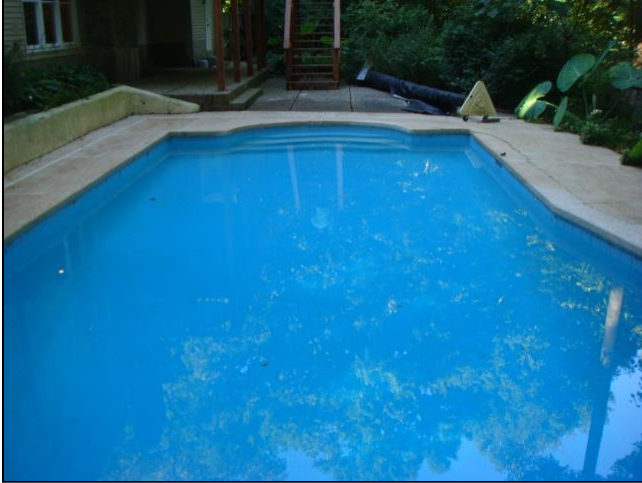
1.7 Item 1(Picture)

1.7 (3) There is a pool present. Pools are not included in the home inspection standards and thus are not tested. However, it was noted that a grey plastic water supply line ran from the inside of the house, out to the pool. This line is above ground and should be evaluated by a pool professional when they come to check the pool. It was also noted that a significant concrete crack was on the pool deck. The pool pro should evaluate this as well.

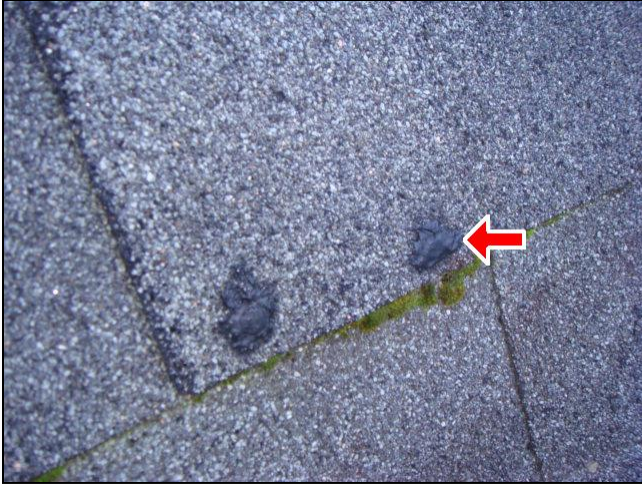
2.1 Item 1(Picture)

2.1 (1) Sealant has been added to flashings on the roof. As regular maintenance, monitor this and keep sealed to insure no moisture entry occurs.

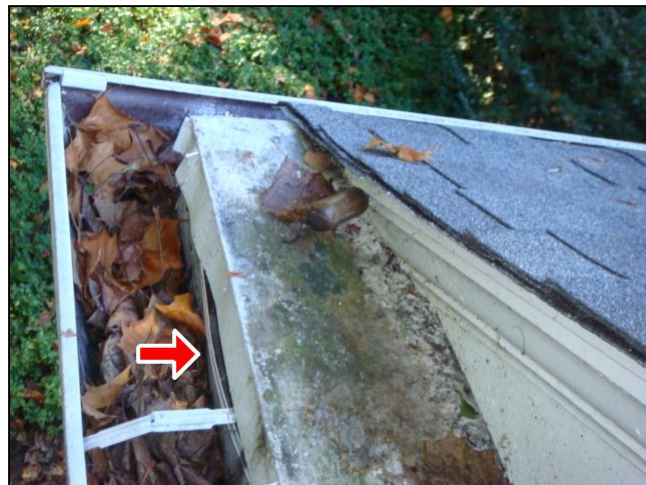
2.1 Item 5(Picture)

2.1 (2) At the right front corner the flashing need adjustment to keep the weather out. Keep flashings in good condition as regular maintenance.

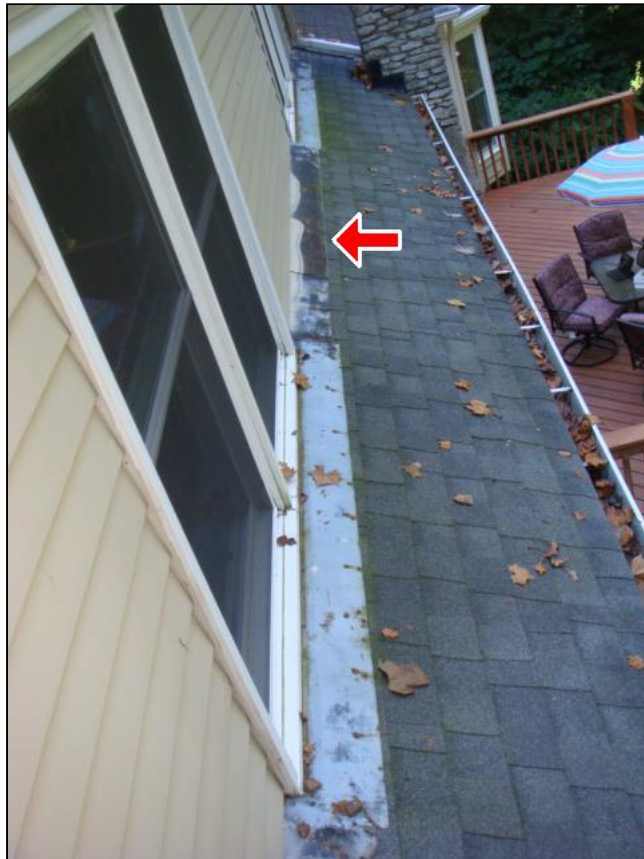
2.1 Item 6(Picture)

2.1 (3) The flashing under the rear windows is showing rust. It appears to be performing it's duties. Suggest you monitor this and contact a qualified contractor if you see changes and need repairs in the future.

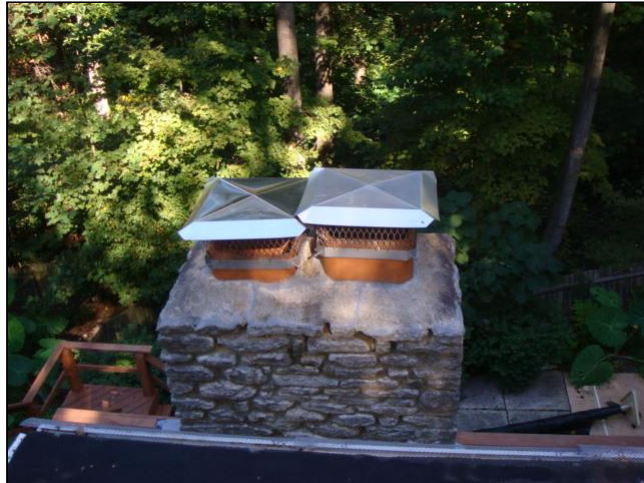
2.2 Item 1(Picture)

2.2 A qualified chimney contractor should be periodically consulted to determine the need for rain caps and/or the presence of blockage or obstructions. Whether the chimney flues are used for functional fireplaces or not, often gas appliances vent thru the chimney and the chimney must be maintained. The concrete chimney top or wash should be kept sealed and the flashing must be maintained to prevent water penetration issues.

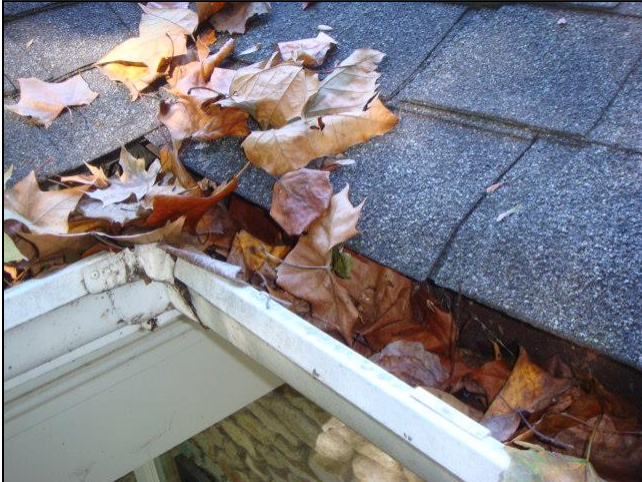
2.3 Item 1(Picture)

2.3 (2) The gutter systems have leaves and debris clogging the gutters and downspouts. The gutters should be kept clean and free of debris as regular maintenance. In addition, gutter debris can cause rust and deterioration that can be concealed during a visual inspection and only appear during periods of rain. Clogged gutters typically overflow and place large amounts of water around the foundation perimeter and cause cracking and water penetration. As part of water management and maximizing drainage keep gutter system cleaned and maintained. Keep downspouts secured and splash blocks placed and aligned under the elbows around the foundation. For best results, add downspout extenders to carry water as far away from the house as possible.

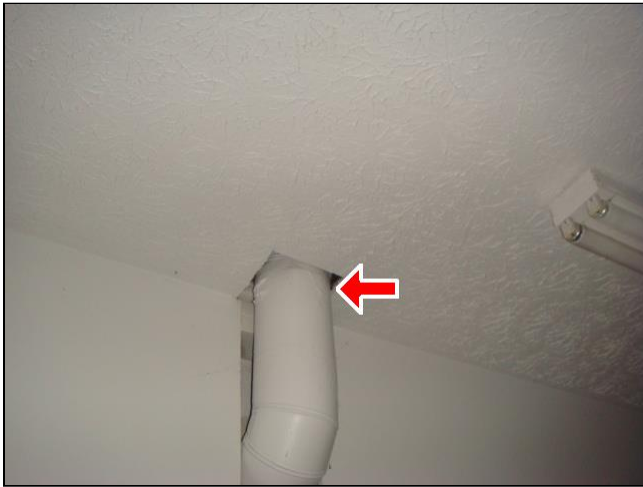
3.0 Item 1(Picture)

3.0 (1) There are holes/penetrations visible in the garage ceiling that are common with the interior. Today's standards require there to be no openings in the ceiling that would allow smoke penetration. Suggest all common interior ceiling be sealed/repaired to maintain fire rating.

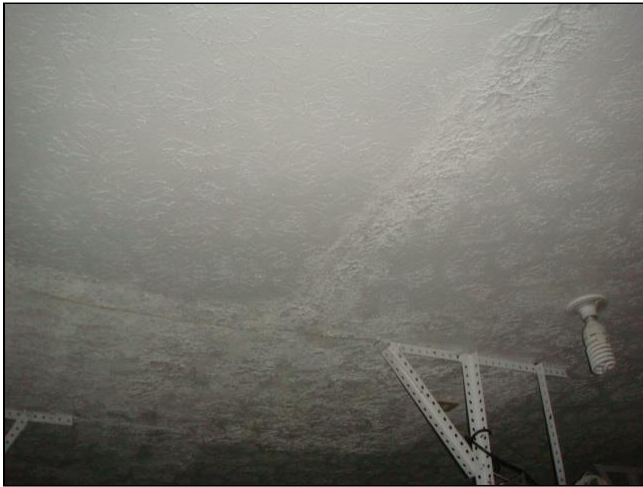
3.0 Item 4(Picture)

3.0 (2) There appears to be a repair and a stain in the garage ceiling. I could find no evidence of moisture related issues in the garage today. Suggest you monitor this and contact a qualified contractor if you see changes and need repairs in the future.

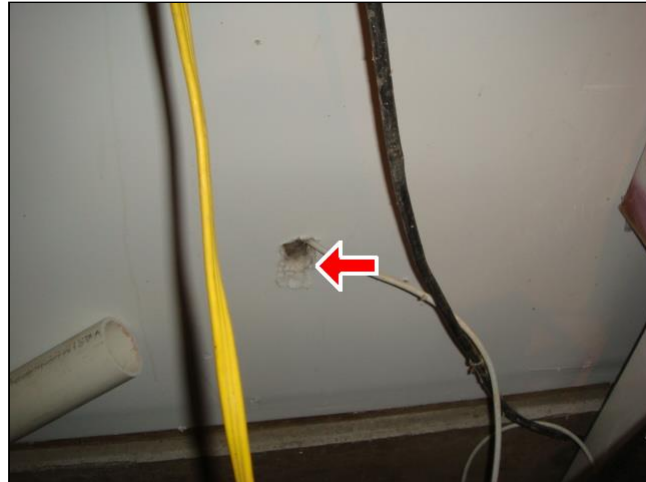
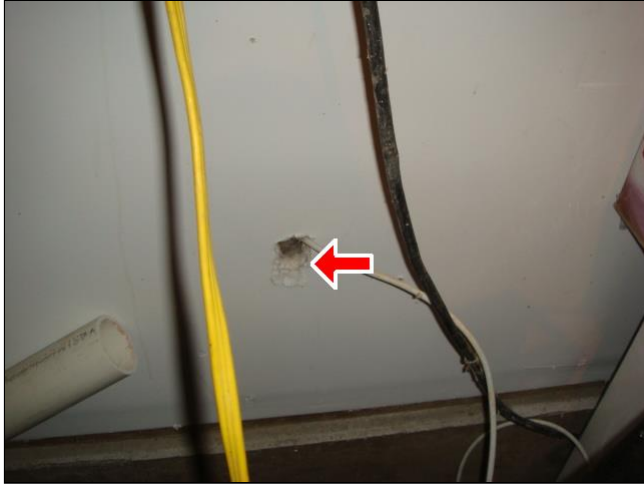
3.1 Item 1(Picture)

3.1 (1) There are holes/penetrations visible in the garage wall(s) and/or ceiling that are common with the interior. Today's standards require there to be no openings in these walls that would allow smoke penetration. Suggest all common interior walls be sealed/repaired to maintain fire rating.

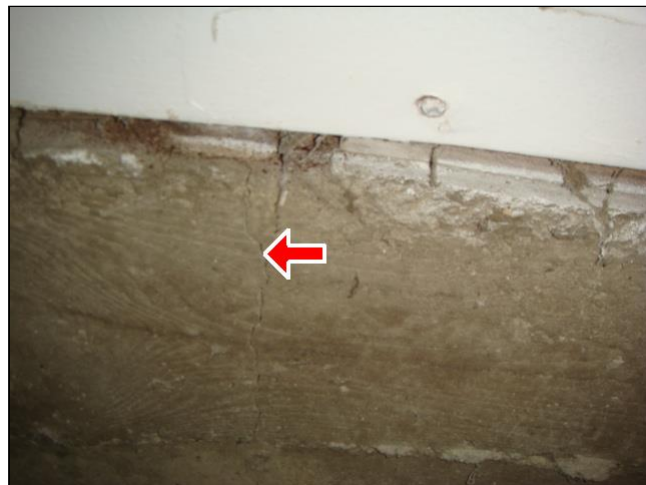
3.1 Item 2(Picture)

3.1 (2) Hairline cracks were noted on the walls. Hairline cracks are common and not considered problematic unless they are active and over a quarter inch wide. Suggest monitoring the cracks and contact a qualified contractor to evaluate and repair if you see cracks getting wider.

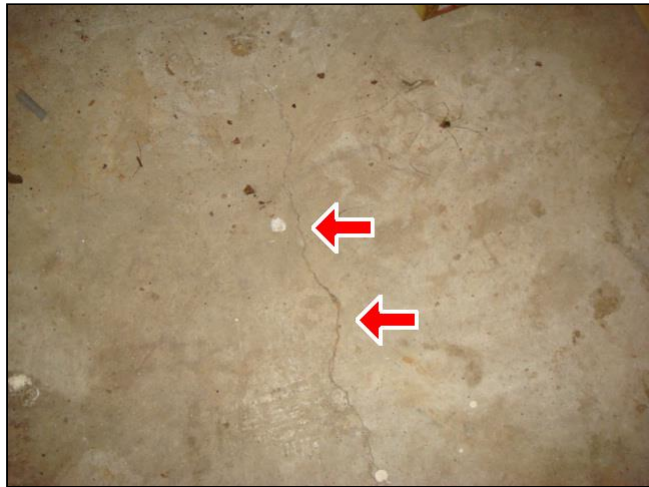
3.2 Item 1(Picture)

3.2 The garage floor surface has cracks and settlement visible. With the weather conditions in this region, surfaces will settle and crack even with the presence of expansion joints due to freezing and thawing. This information is supplied as a courtesy. No repair is necessary.

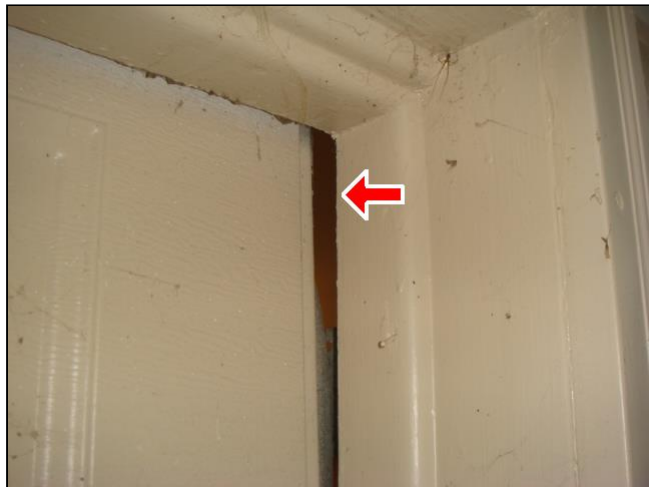
3.3 Item 1(Picture)

3.3 One of the garage doors is ill fitting. It works fine. But, you may want to consider a repair/adjustment so it fits better.

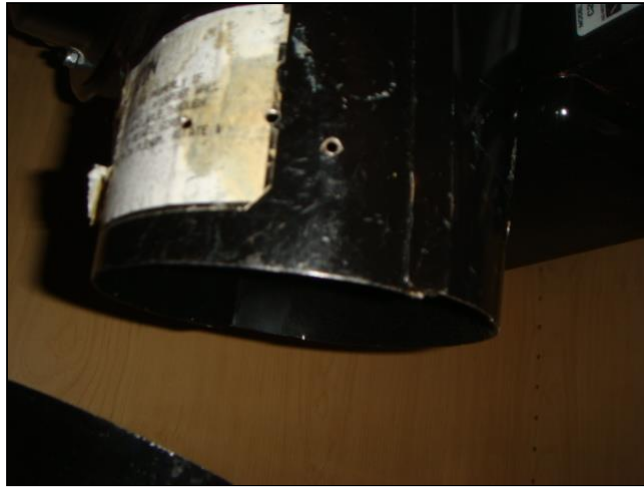
4.2 Item 1(Picture)

4.2 The hood vent line has been disconnected and it does not respond to it's switch. Suggest contact a qualified contractor repair/replace.

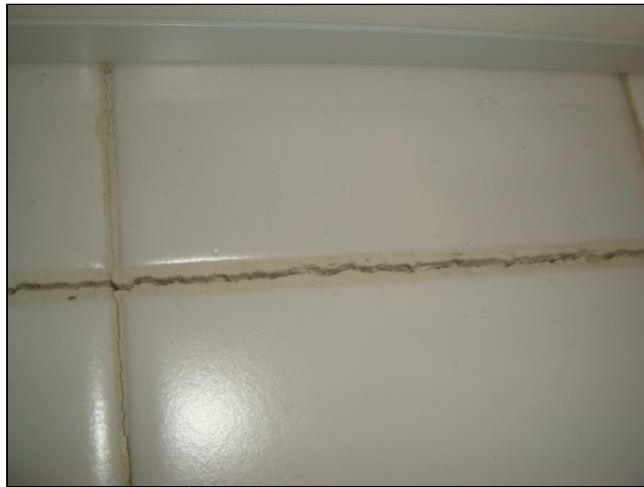
5.1 Item 1(Picture)

5.1 (1) Caulking and grouting around tub and shower enclosures are needed periodically to prevent moisture penetration and interior damage. Structural or cosmetic damage to the underlying wall or floor/ceiling areas may occur if left unattended. The need to periodically repair leaking faucets and/or shutoff valves and clear slow or blocked drains should be expected as part of normal routine maintenance.

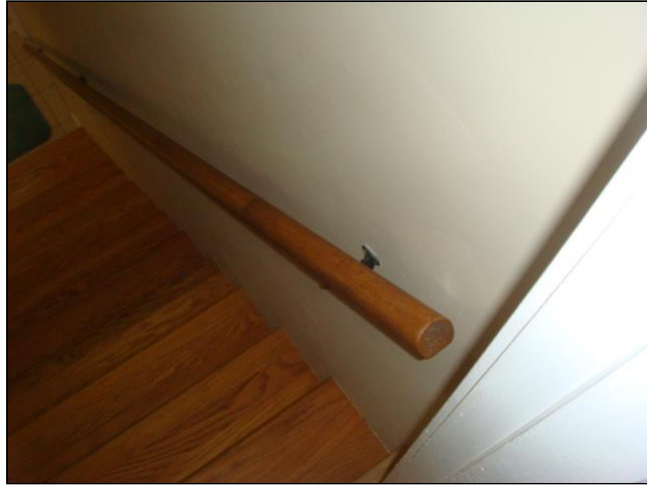
5.3 Item 1(Picture)

5.3 The handrails are not typical of the ones required by today's standards. The ends of the handrail are now required to return to the wall at the top and bottom. The rail in place has exposed ends with no return that can catch on clothes and cause a fall hazard. Railings with returns were not required when this house was built, so you could add as an upgrade. Be careful.

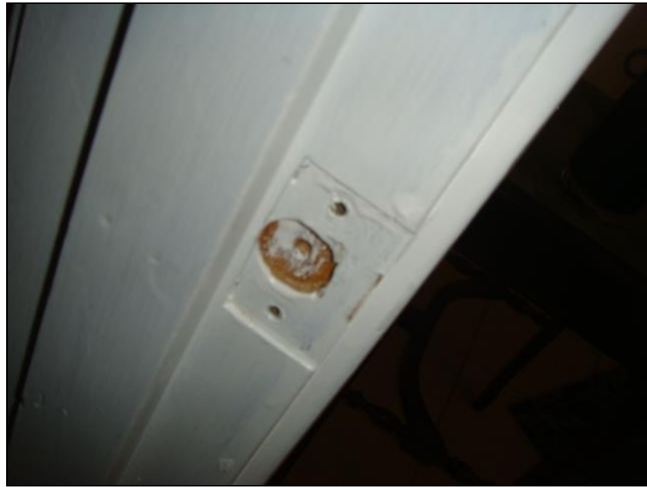
5.5 Item 1(Picture)

5.5 A door is missing a strike plate. Suggest contact a qualified contractor repair/replace.

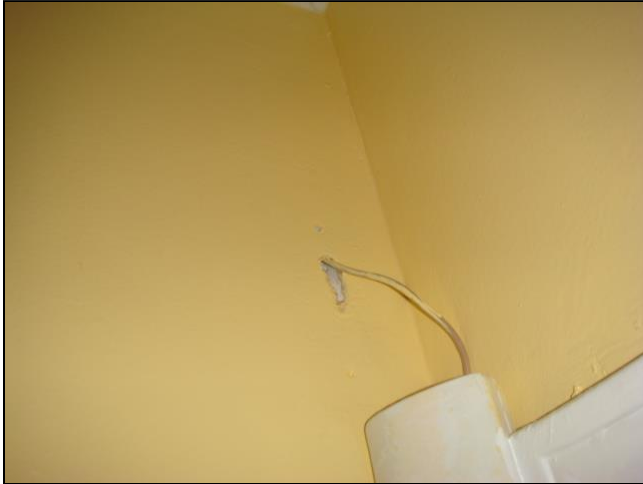
5.7 Item 1(Picture)

5.7 There are imperfections (dings, ruff spots, etc) on some of the interior finishes. These are cosmetic in nature and can be repaired if you desire.

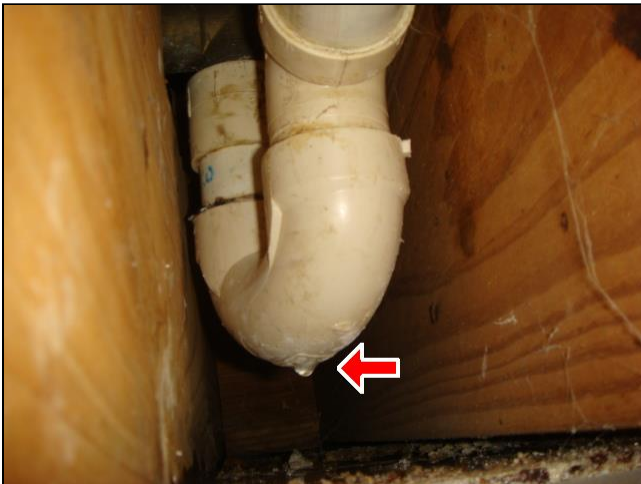
6.0 Item 1(Picture)

6.0 (1) There is a leak under the sink in the bath off of the office & there is a leak that manifests in the basement that appears to come from this bath . Suggest a qualified contractor repair.

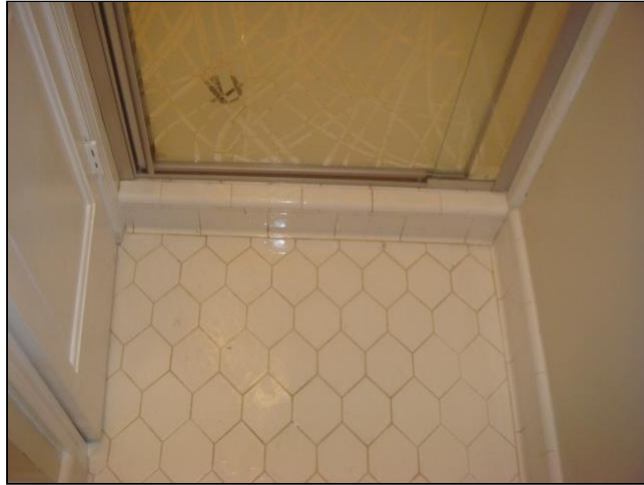
6.1 Item 1(Picture)

6.1 When the basement shower is run, water leaks out around the door and onto the floor. Suggest contact a qualified contractor repair/replace.

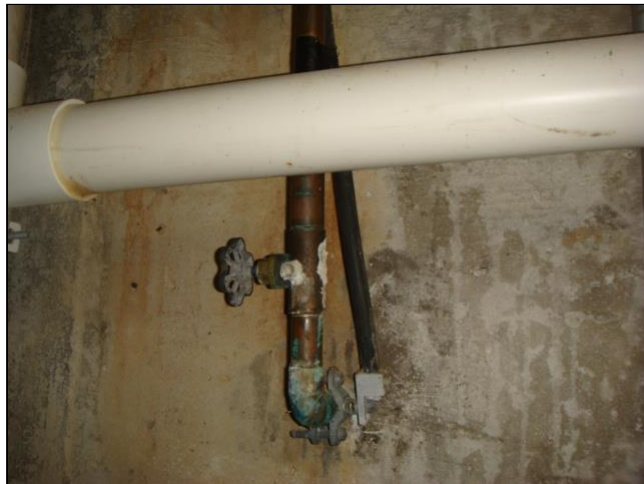
6.3 Item 1(Picture)

6.3 Main water shutoff is in the basement.

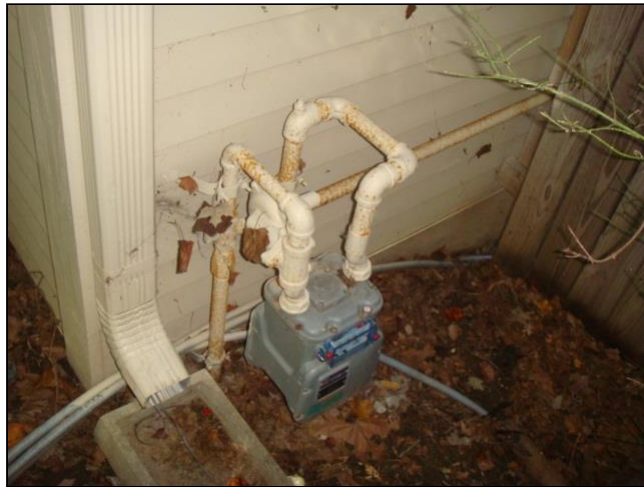
6.5 Item 1(Picture)

6.5 The main fuel shut off is at gas meter outside

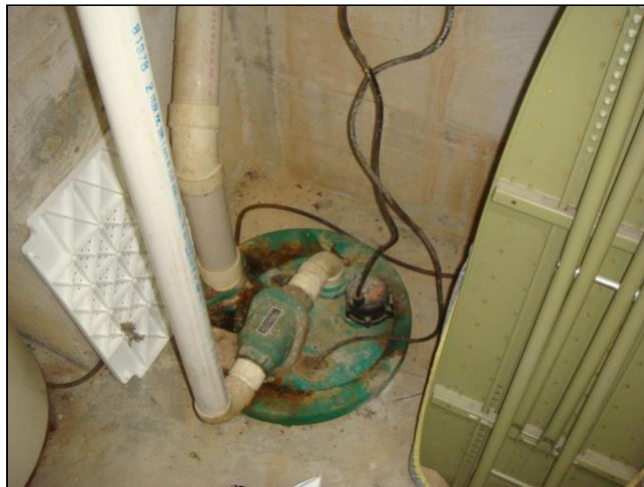
6.6 Item 1(Picture)

6.6 Sump pumps and Ejector pumps are tested when possible. These pumps are often sealed systems (this one is) which prevented visually inspecting, but I tested it by plugging it directly in and it worked. These pumps are electrically powered and the loss of power would prevent their function. In the scenario of a storm with loss of power, the crocks/ basins could fill with water and cause basement flooding. Although battery back-ups are not required, it is suggested that once you buy a house, you add battery back-up systems, as an upgrade, to protect your property.

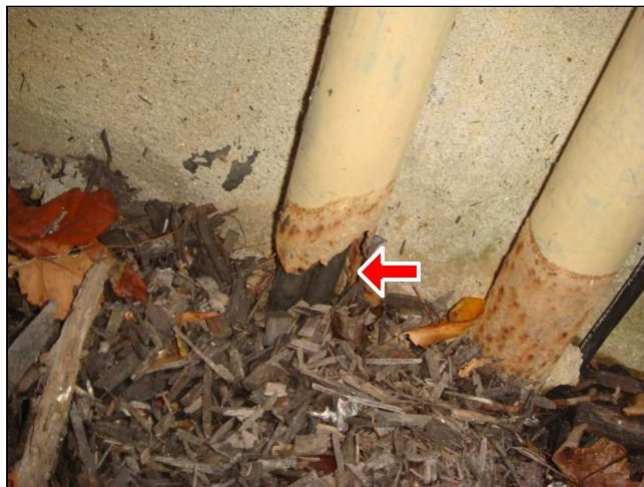
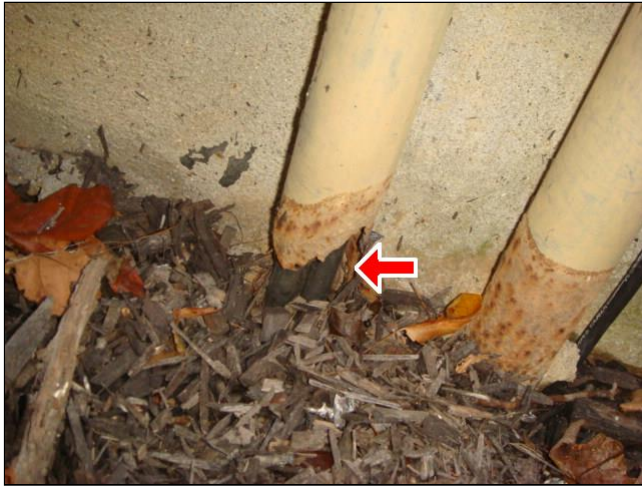
7.0.A Item 1(Picture)

7.0.A The service entry cables are no longer protected by their sheathing as it has deteriorated/moved. Suggest a qualified contractor evaluate and make necessary repairs.

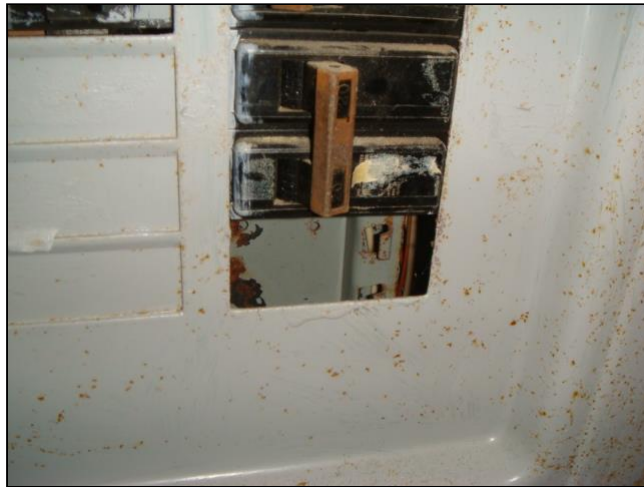
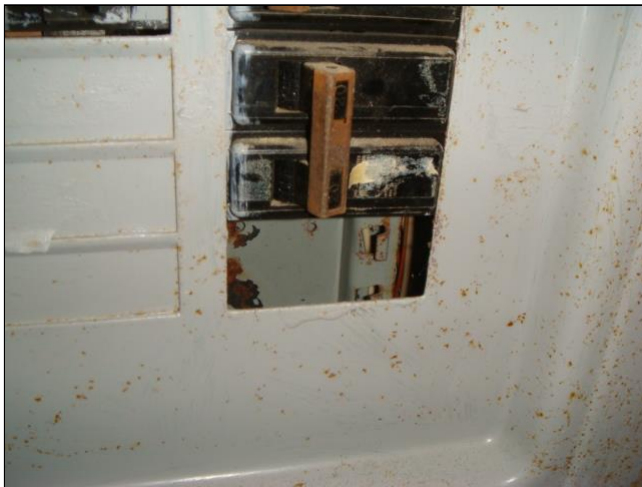
7.1.A Item 1(Picture)

7.1.A There are unprotected panel openings that should be evaluated/ repaired. All the openings of the panel should be covered and any opening is considered a safety hazard.

There are unprotected panel openings that should be evaluated/repaired. All the openings of the panel should be covered and any opening is considered a safety hazard.

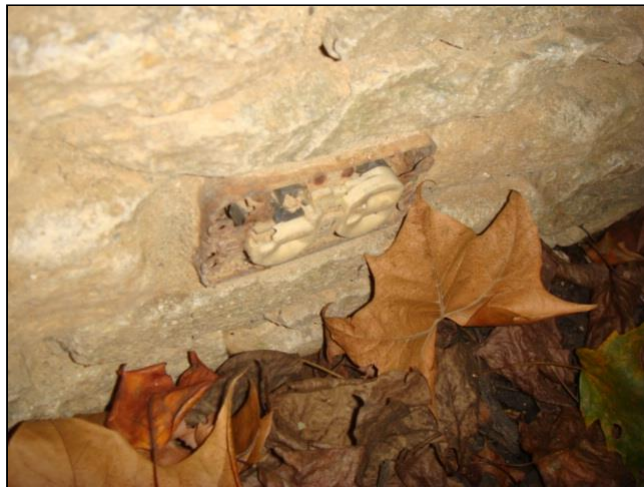
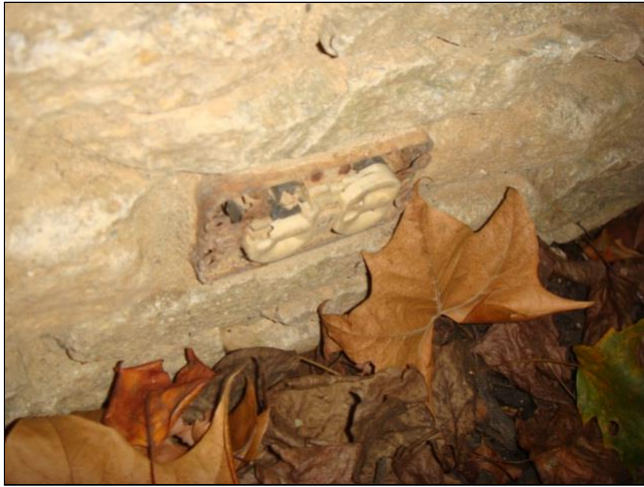
7.3.A Item 1(Picture)

7.3.A (1) There was a front exterior outlet noted with no protective cover. It is suggested a qualified person evaluate the house for missing covers and replace as necessary for safety.

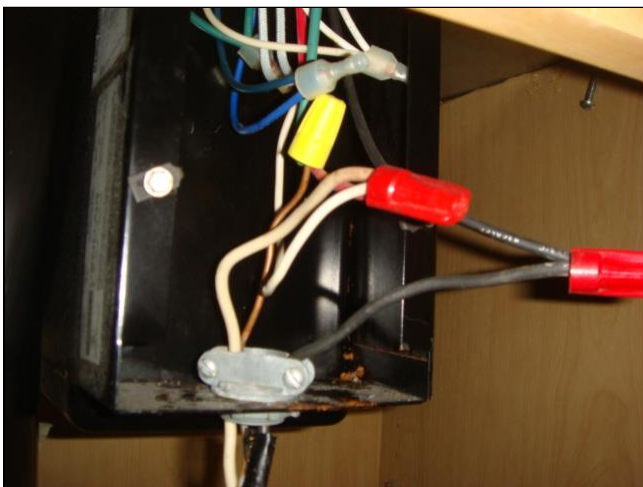
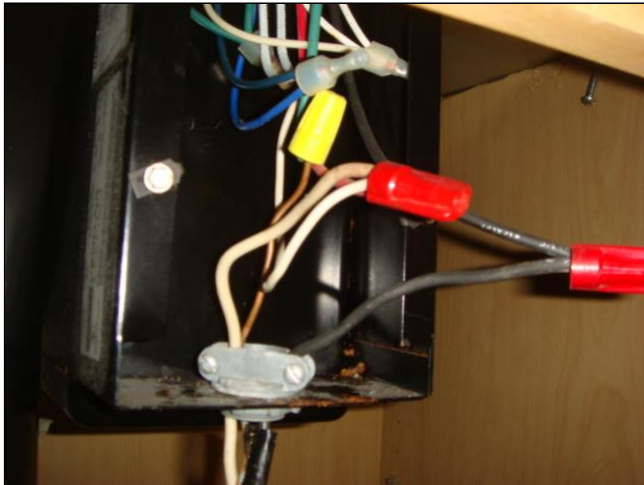
7.3.A Item 2(Picture)

7.3.A (2) There are open/uncovered electrical wire junctions in the basement ceiling and under the cooktop in the kitchen. Uncovered or open air junctions are considered a fire and safety hazard and the system should be evaluated by a qualified contractor for these type of issues and repaired as necessary.

(2) There are open/uncovered electrical wire junctions in the basement ceiling and under the cooktop in the kitchen. Uncovered or open air junctions are considered a fire and safety hazard and the system should be evaluated by a qualified contractor for these type of issues and repaired as necessary.

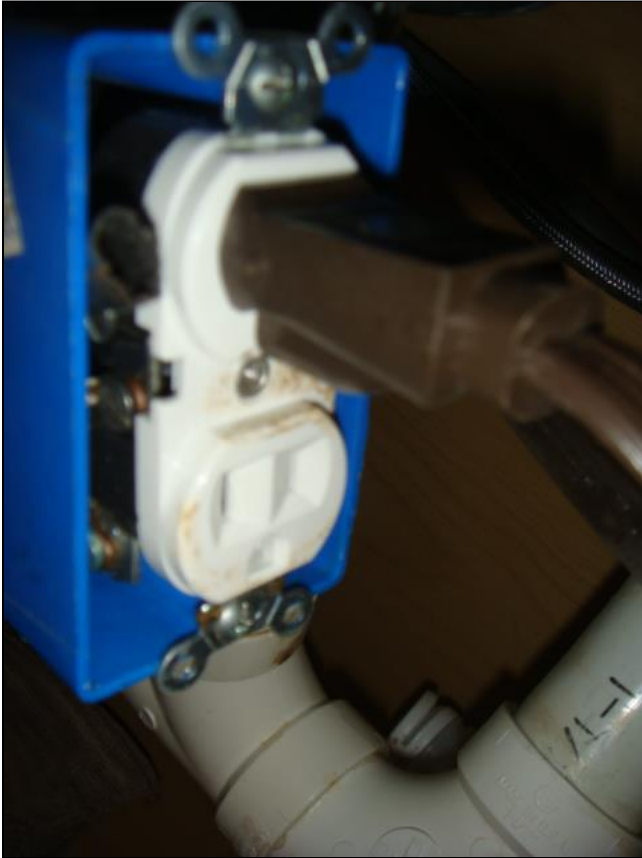
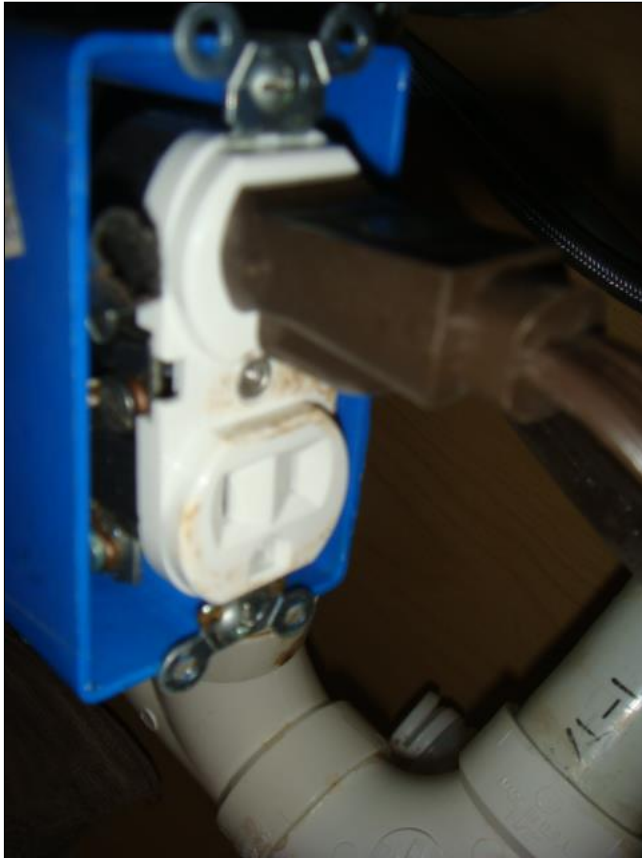
7.3.A Item 4(Picture)

7.3.A (3) There was an outlet under the sink noted with no protective cover and one in the basement that has a gap wide enough to get behind it. It is suggested a qualified person evaluate the house for missing covers and replace as necessary for safety.

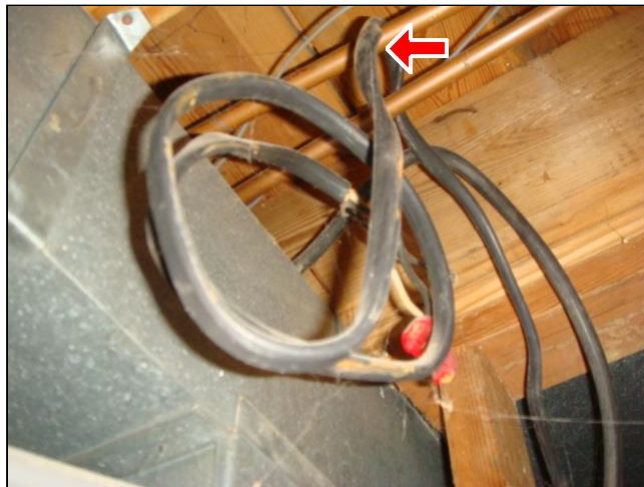
7.3.A Item 6(Picture)

7.3.A (4) There is wiring in contact with metal piping and/or duct. Electrical wiring should be secured up out of contact with other metal for safety purposes. Suggest qualified contractor evaluate all wiring and make necessary repairs/ alternatives.

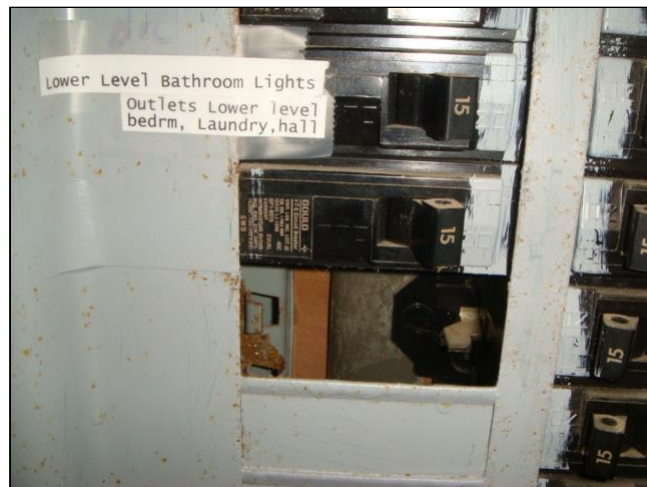
7.1.B Item 1(Picture)

7.1.B There are unprotected panel openings that should be evaluated/ repaired. All the openings of the panel should be covered and any opening is considered a safety hazard.

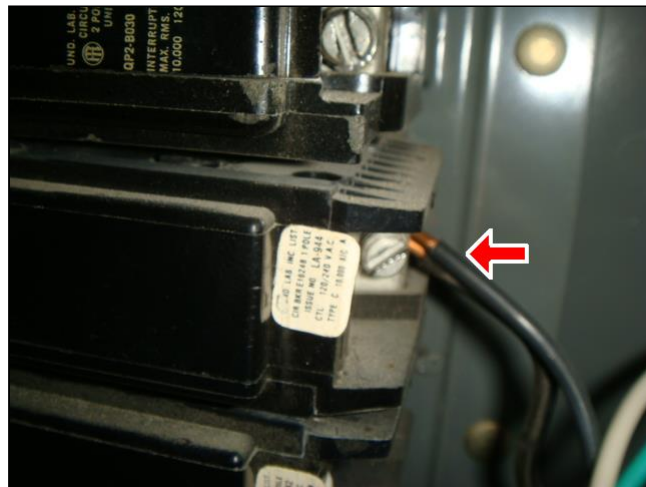
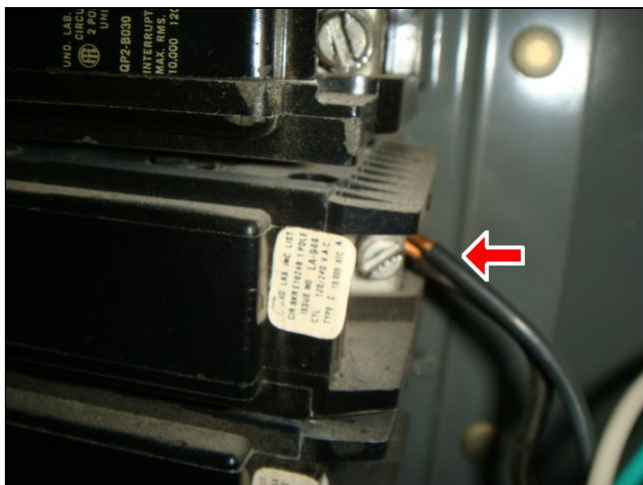
7.2.C Item 1(Picture)

7.2.C There is double tapping of breakers visible in the panel. Breakers with more than one wire connected are considered double tapped and-with few exceptions- should be evaluated/ repaired by a qualified contractor.

There is double tapping of breakers visible in the panel. Breakers with more than one wire connected are considered double tapped and-with few exceptions- should be evaluated/repaired by a qualified contractor.

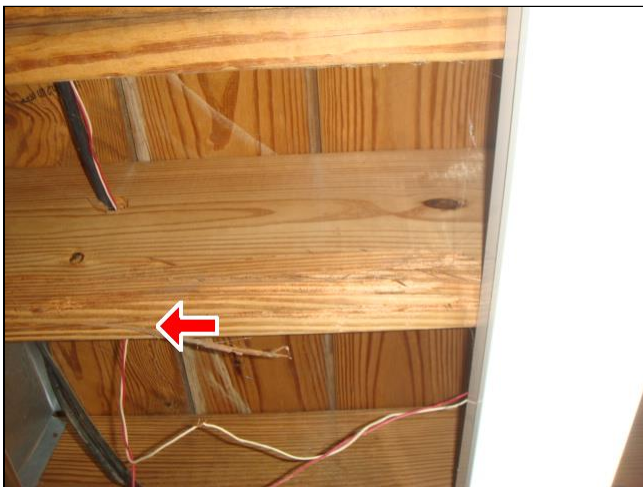
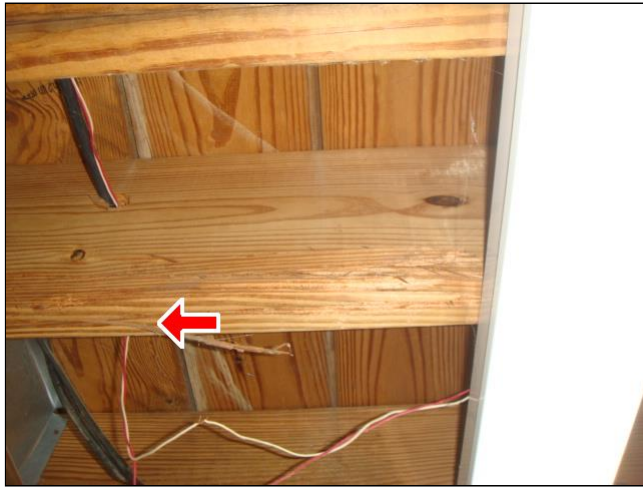
9.3 Item 1(Picture)

9.3 There is a split joist and a splintered joist visible from the basement. Suggest a qualified contractor evaluate and make necessary repairs.

There is a split joist and a splintered joist visible from the basement. Suggest a qualified contractor evaluate and make necessary repairs.

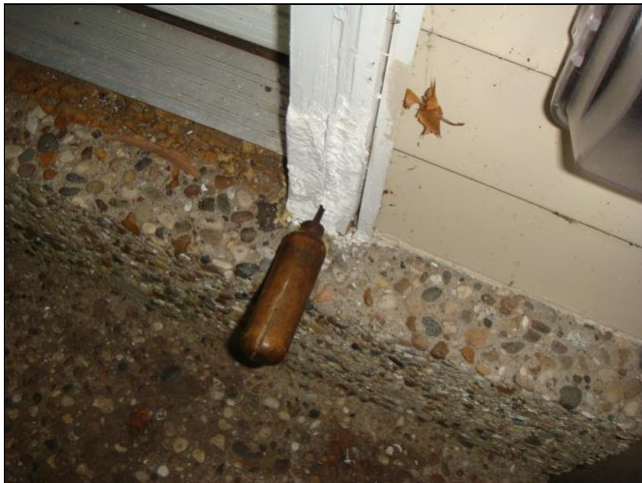
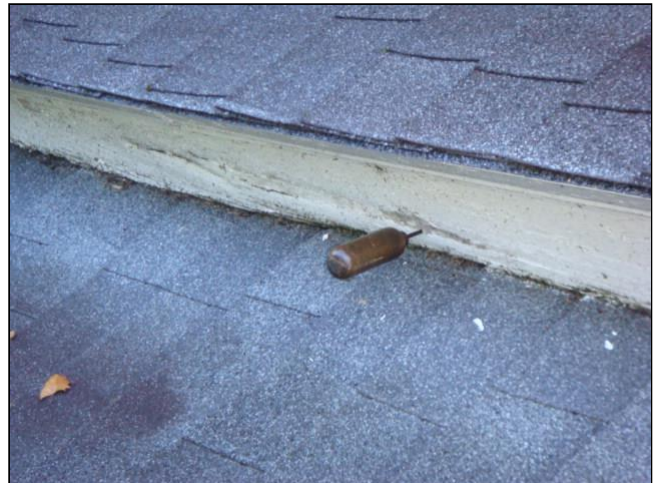
1.3

(3) There is rot/deterioration noted in some wood trim around the structure. These areas include, but are not limited to back basement door and fascia board on the roof. Suggest qualified contractor evaluate all wood trim and repair as necessary.
