Inspection Report

Property Address:
1111 Wooded Rd
Louisville Ky 40205

HayStack Inspection Services

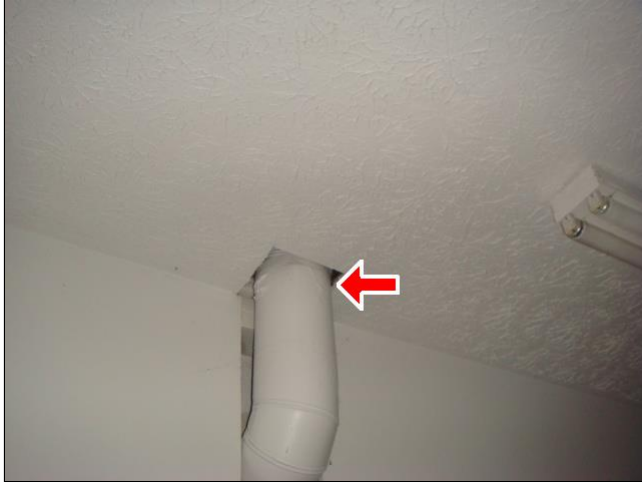
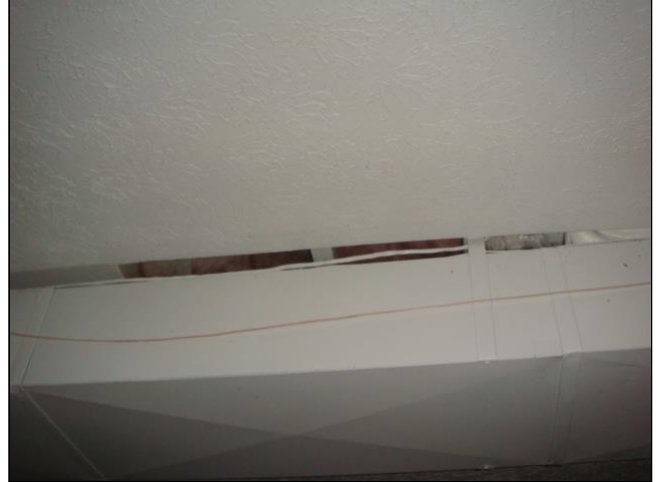
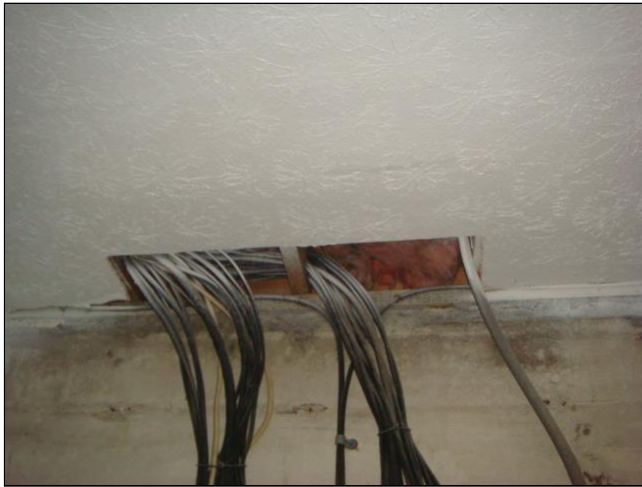
3.0

(1) There are holes/penetrations visible in the garage ceiling that are common with the interior. Today's standards require there to be no openings in the ceiling that would allow smoke penetration. Suggest all common interior ceiling be sealed/repaired to maintain fire rating.

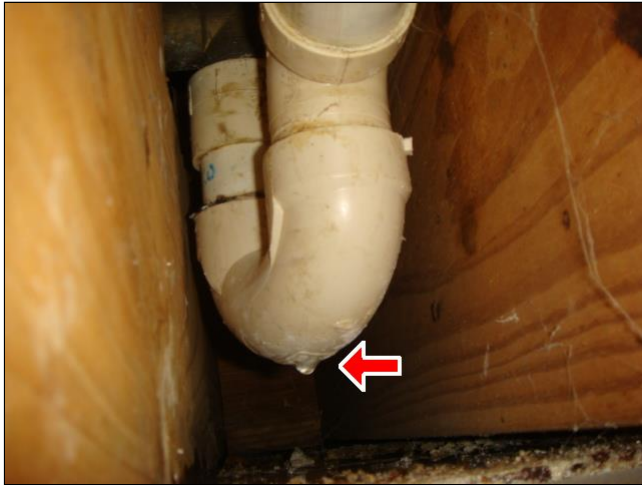
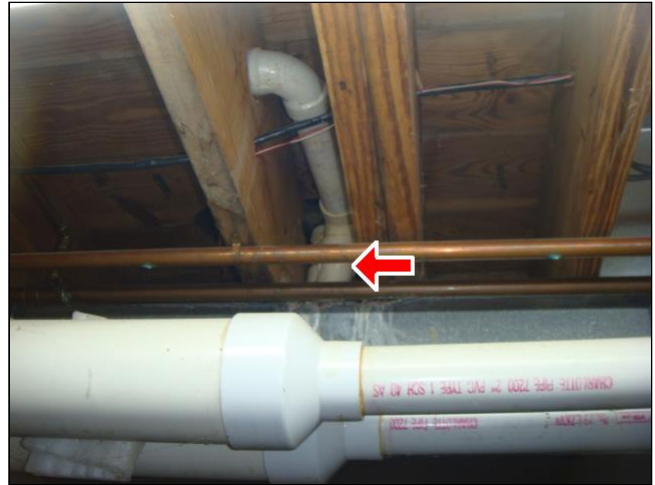
6.0

(1) There is a leak under the sink in the bath off of the office & there is a leak that manifests in the basement that appears to come from this bath . Suggest a qualified contractor repair.

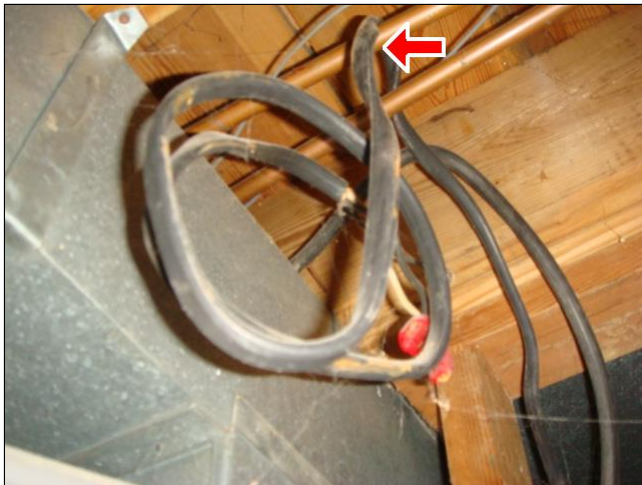
7.3.A

(4) There is wiring in contact with metal piping and/or duct. Electrical wiring should be secured up out of contact with other metal for safety purposes. Suggest qualified contractor evaluate all wiring and make necessary repairs/alternatives.

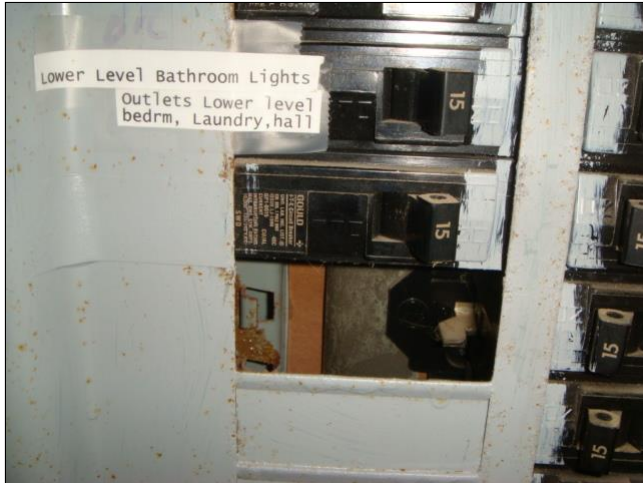
7.1.B

There are unprotected panel openings that should be evaluated/repaired. All the openings of the panel should be covered and any opening is considered a safety hazard.
